Manhole Inspection Summary

Manhole # S31II_017MH

Location Address: **1401 MOSHER ST**

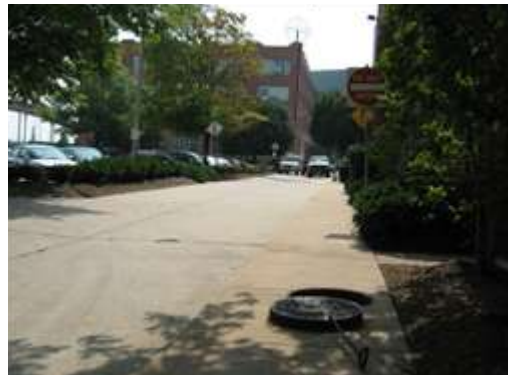
Location View

behind 1401 Mt. Royal Ave

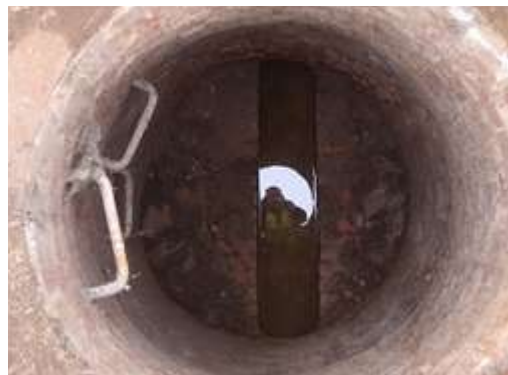
Top View

Evidence of surcharge - Bench debris.

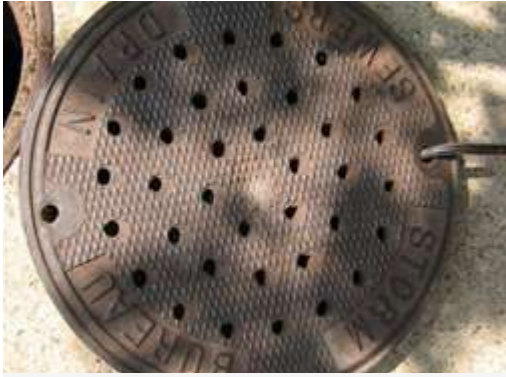
storm drian cover

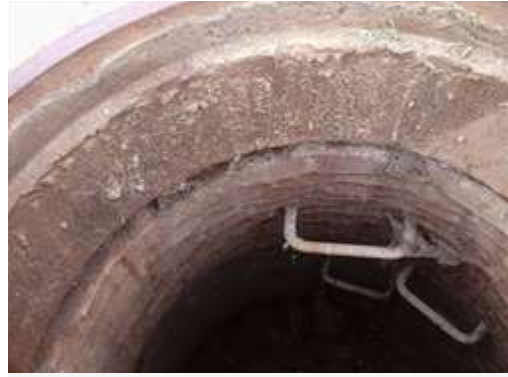
Defect

Frame leaks. Adjustment deterioration and infiltration. Corbel infiltration - other side.

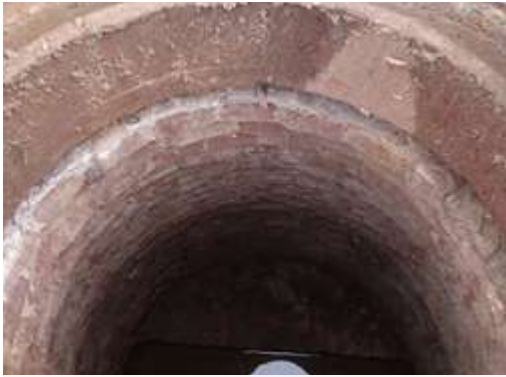
Defect

Frame leaks. Adjustment deterioration and infiltration. Corbel infiltration.

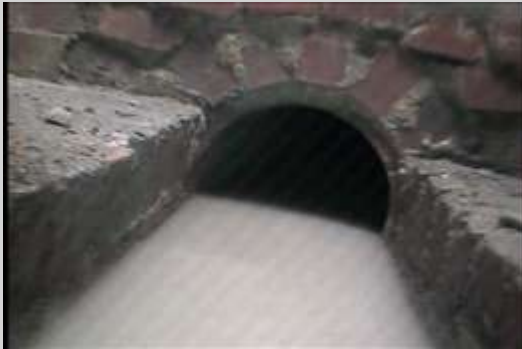
12 in. Circular Gravity Sewer Pipe Out @ 12 O'Clock

Infiltration: **Evidence** Pipe Seal Cond: **Unknown**
